Restoring the Back Burn Project Overview

As part of the Leven Programme our aim is to restore 5.8 kilometres of the Back Burn (also known as the Conland, Coul and Balbirnie Burn in these areas!) to a more natural state between Rhind Hill in the Lomond Hills and Newton, north of Markinch.

Restoring the Back Burn Proposed Improvements

Restoring the Back Burn Coul Den

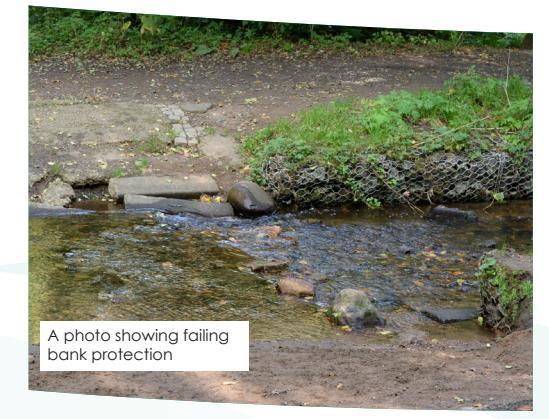
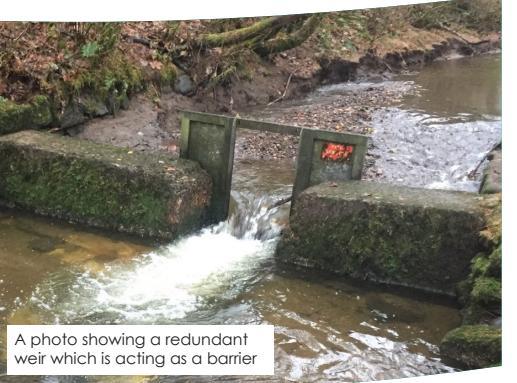
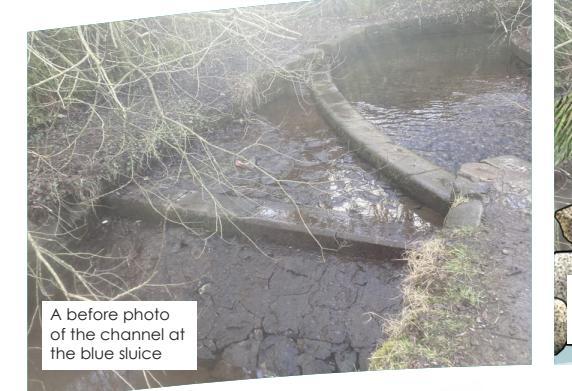
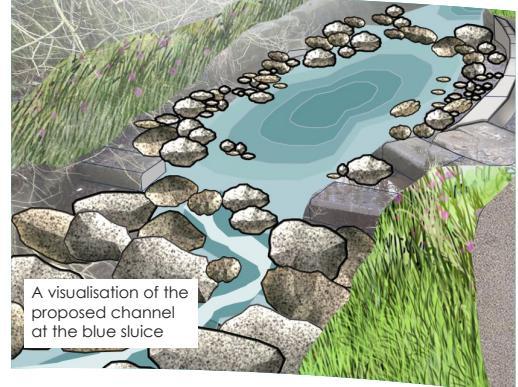
- Remove small redundant barriers such as boundary posts, walls and fences crossing the burn **allowing the river to flow unrestricted and sediment to move more freely**, as it would in a natural channel.
- Removing rock and stone bank protection **allowing the burn to reconnect to the floodplain**.
- At Coul Den rerouting the burn fully down its **original natural channel**, creating significant ecological benefits.
- Wetland planting along the banks and floodplain areas to improve biodiversity.
- Remove the large gabion baskets (stone filled wire baskets) at Coul Den and replacing them with a more attractive and naturally functioning step pool like alternative.

- Remove the large gabion baskets (stone filled wire baskets) downstream of Coul Reservoir replacing them with a more attractive and natural functioning step pool like channel.
- Where practical **removing small weirs** within Balbirnie Park to improve habitat for resident fish populations This will involve adapting the weir to allow the burn to reconnect with its original channel around the blue sluice gate. Once water begins to flow down the original channel more will flow into and leave the reservoir. This will improve local ecology and wet woodland habitat around this area

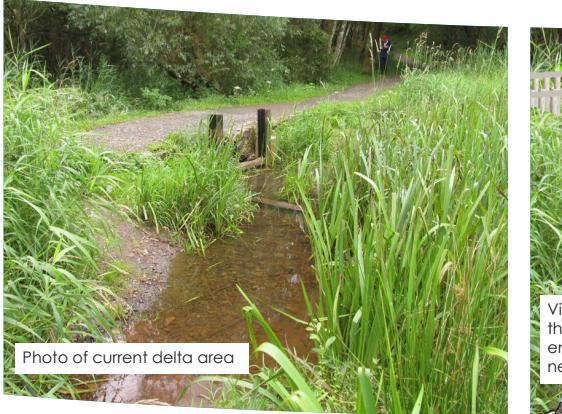
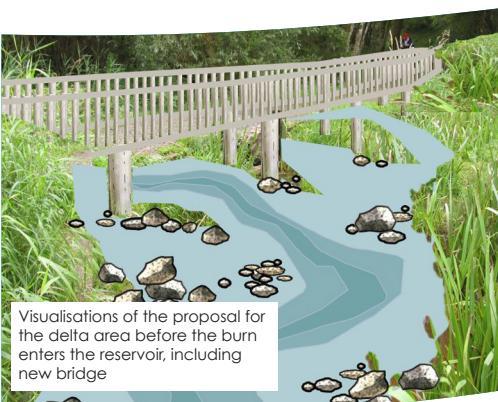
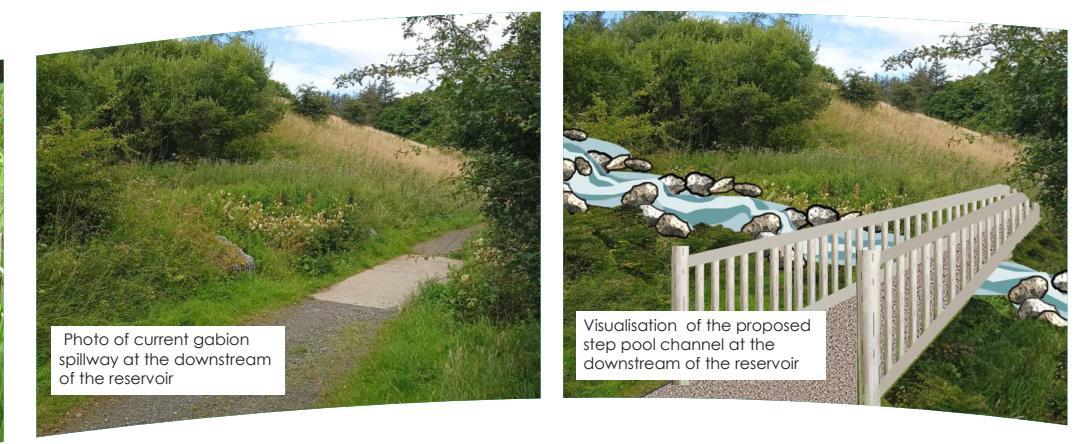
Historically, the burn flowed through what is now Coul Reservoir. In the late 1800's the reservoir was constructed for the Haig Distillery and a long, straight, cobble lined artificial channel was built to take the river flow past the reservoir. The distillery is no longer there and the reservoir redundant therefore there is an excellent opportunity to reconnect the burn with its natural channel.

A bridge will be installed within the current path network to allow for the burn to flow into the reservoir more freely as it establishes its natural route.

The reservoir will be retained to protect the large variety of aquatic plants and birds that are present today. At the downstream side of the reservoir, we are proposing to replace the large section of gabions (wire baskets filled with stones) with a more natural step pool feature. We plan to remove the concrete crossing point replacing it with a bridge to allow access along the path network all year and to allow the river to flow more freely underneath.

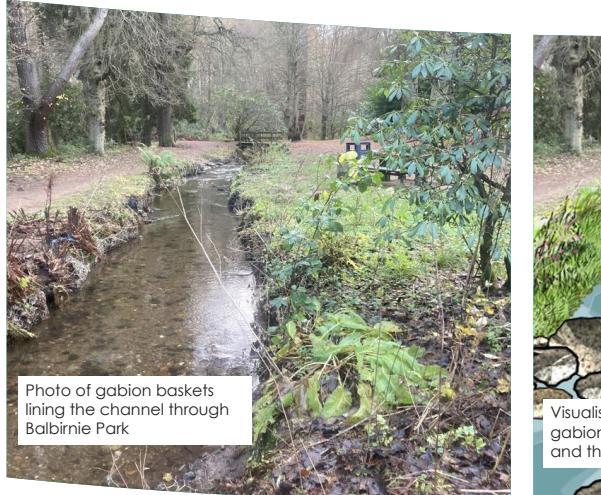
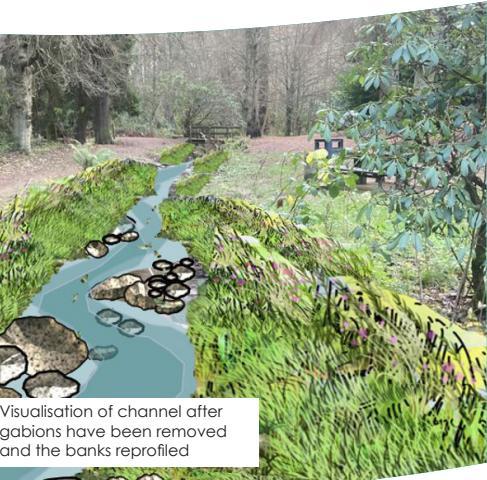
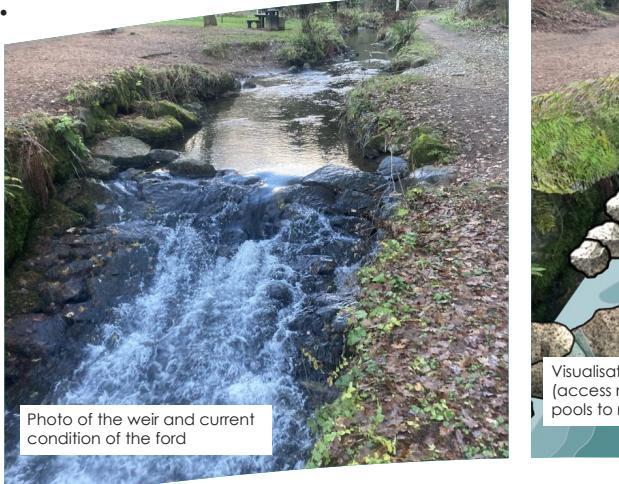
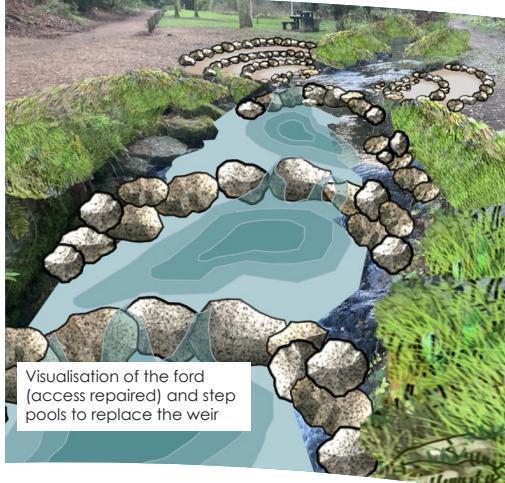
Where possible we are proposing to remove sections of gabions (stone filled wire baskets), walls and cobbled areas that have been inserted into the burn in the past that prevent it from functioning naturally.

In addition there are a number of small weirs that confine the burn and we are proposing to remove these letting the river re-naturalise and recover over time.
